Spark Plug Faces

Spark Plug Gapping

Spark Plug Heat Range

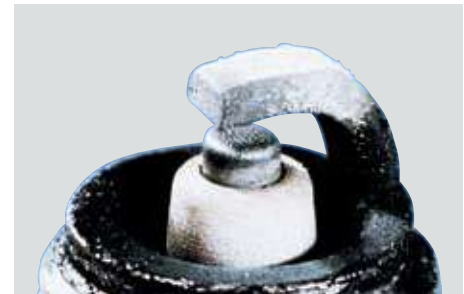
1. Normal Condition

Insulator nose grayish-white or grayish-yellow to brown. Engine is in order. Heat range of plug correct. Mixture setting and ignition timing are correct, no misfiring, cold-starting device functioning. No deposits from fuel additives containing lead or from alloying constituents in the engine oil. No overheating.

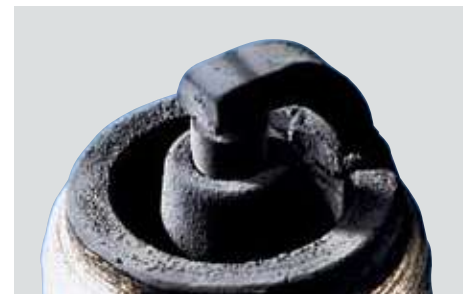
2. Sooted – Carbon-fouled

Insulator nose, electrodes and spark plug shell covered with velvet-like dull black soot deposits.

Cause: Incorrect mixture setting (carburetor fuel injection); mixture too rich, air filter very dirty, automatic choke not in order or manual choke pulled too long, mainly short-distance driving, spark plug too cold, heat-range code number too low.

Effects: Misfiring, difficult cold-starting.

Remedy: Adjust A/F mixture and choke device, check air filter.

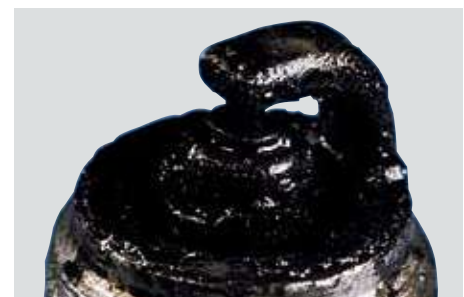
3. Oil-fouled

Insulator nose, electrodes and spark-plug shell covered with shiny soot or carbon residues.

Cause: Too much oil in combustion chamber. Oil level too high, badly worn piston rings, cylinders and valve guides. In two-stroke engines, too much oil in mixture.

Effects: Misfiring, difficult starting.

Remedy: Overhaul engine, adjust oil/fuel ratio (2-stroke engines), fit new spark plugs.

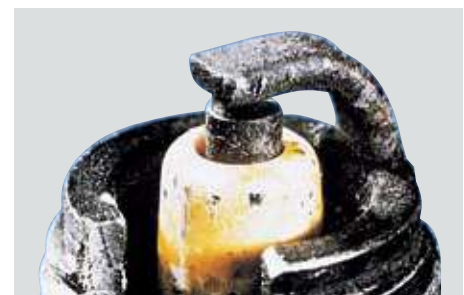
4. Lead fouling

Insulator nose covered in places with brown/yellow glazing, which can have a greenish color.

Cause: Lead additives in fuel. Glazing results from high engine loading after extended part-load operation.

Effects: At high loads, the glazing becomes conductive and causes misfiring.

Remedy: Fit new spark plugs since cleaning the old one is pointless.

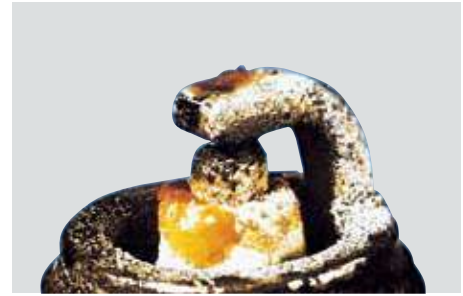
5. Pronounced lead fouling

Insulator nose covered in places with thick brown/yellow glazing, which can have a greenish color.

Cause: Lead additives in fuel. Glazing results from high engine loading after extended partload operation.

Effects: At high loads the glazing becomes conductive and causes misfiring.

Remedy: Fit new spark plugs since cleaning the old ones is pointless.

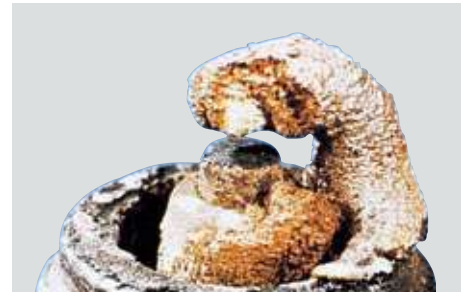
6. Formation of ash

Heavy ash deposits on the insulator nose resulting from oil and fuel additives, in the scavenging area and on the ground electrode. The structure of the ash is loose to cinder-like.

Cause: Alloying constituents, particularly from engine oil, can deposit this ash in the combustion chamber and on the spark-plug face.

Effects: Can lead to auto-ignition with loss of power and possible engine damage.

Remedy: Repair the engine. Fit new spark plugs. Possibly change engine-oil type.

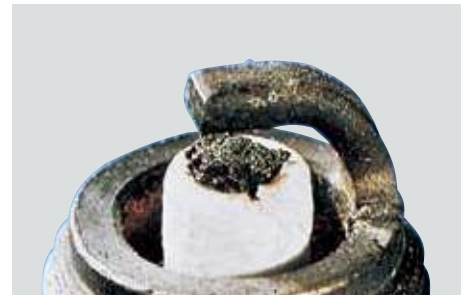
7. Center electrode covered with melted deposits

Melted deposits on center electrode. Insulator tip blistered, spongy and soft.

Cause: Overheating caused by auto-ignition. For instance, due to ignition being too far advanced, combustion deposits in the combustion chamber, defective valves, defective ignition distributor, poor-quality fuel. Possibly, spark-plug heat-range value is too low.

Effects: Misfiring, loss of power (engine damage).

Remedy: Check the engine, ignition and mixture formation system. Fit new spark plugs with correct heat-range code number.

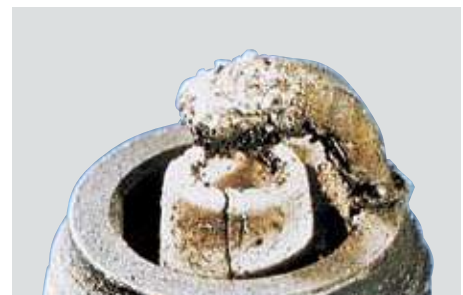
8. Partially melted center electrode

Center electrode has melted and ground electrode is severely damaged.

Cause: Overheating caused by auto-ignition. For instance, due to ignition being too far advanced, combustion deposits in the combustion chamber, defective valves, defective ignition distributor, poor-quality fuel.

Effects: Misfiring, loss of power (engine damage).

Insulator-nose fracture, possibly due to overheated center electrode.

Remedy: Check the engine, ignition and mixture-formation system. Fit new spark plugs.

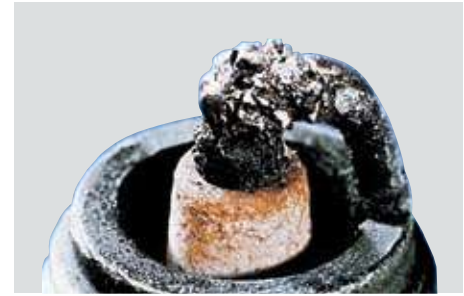
9. Partially melted electrodes

Cauliflower-like appearance of the electrodes. Possible deposit of materials not originating from the spark plug.

Cause: Overheating caused by auto-ignition. For instance, due to ignition being too far advanced, combustion deposits in the combustion chamber, defective valves, defective ignition distributor, poor-quality fuel.

Effects: Power loss becomes noticeable before total failure occurs (engine damage).

Remedy: Check engine and mixture-formation system. Fit new spark plugs.

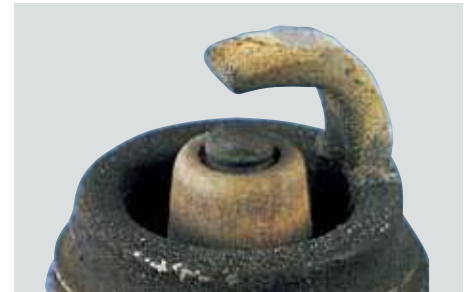
10. Heavy wear on center electrode

Cause: Spark plug exchange interval has been exceeded

Effects: Misfiring, particularly during acceleration (ignition voltage no longer sufficient for the large electrode gap). Poor starting.

Remedy: Fit new spark plugs.

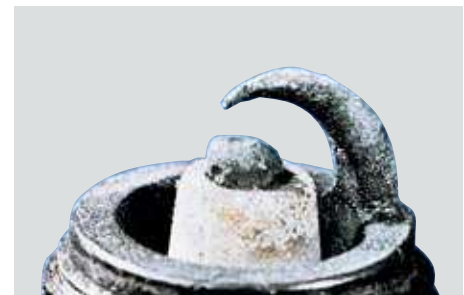
11. Heavy wear on ground electrode

Cause: Aggressive fuel and oil additives. Unfavorable flow conditions in combustion chamber, possibly as a result of combustion deposits. Engine knock. Overheating has not taken place.

Effects: Misfiring, particularly during acceleration (ignition voltage no longer sufficient for the large electrode gap). Poor starting.

Remedy: Fit new spark plugs.

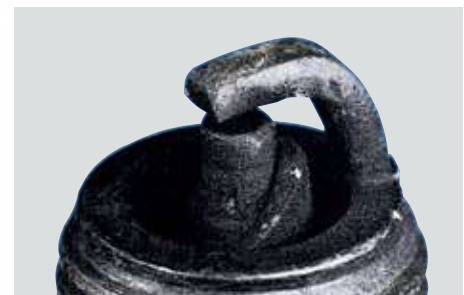
12. Insulator-nose fracture

Cause: Mechanical damage (spark plug has been dropped or bad handling has put pressure on the center electrode). In exceptional cases, deposits between the insulator nose and the center electrode, as well as center-electrode corrosion, can cause the insulator nose to fracture (this applies particularly for excessively long periods of use).

Effects: Misfiring, spark arcs-over at a point that is inaccessible for the fresh charge of A/F mixture.

Remedy: Fit new spark plugs.

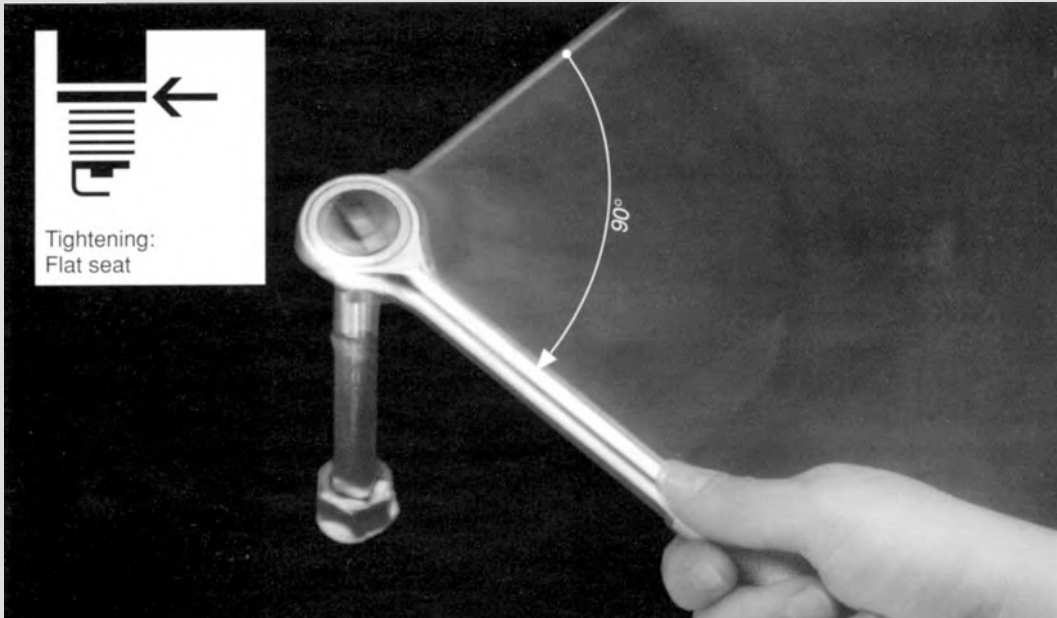
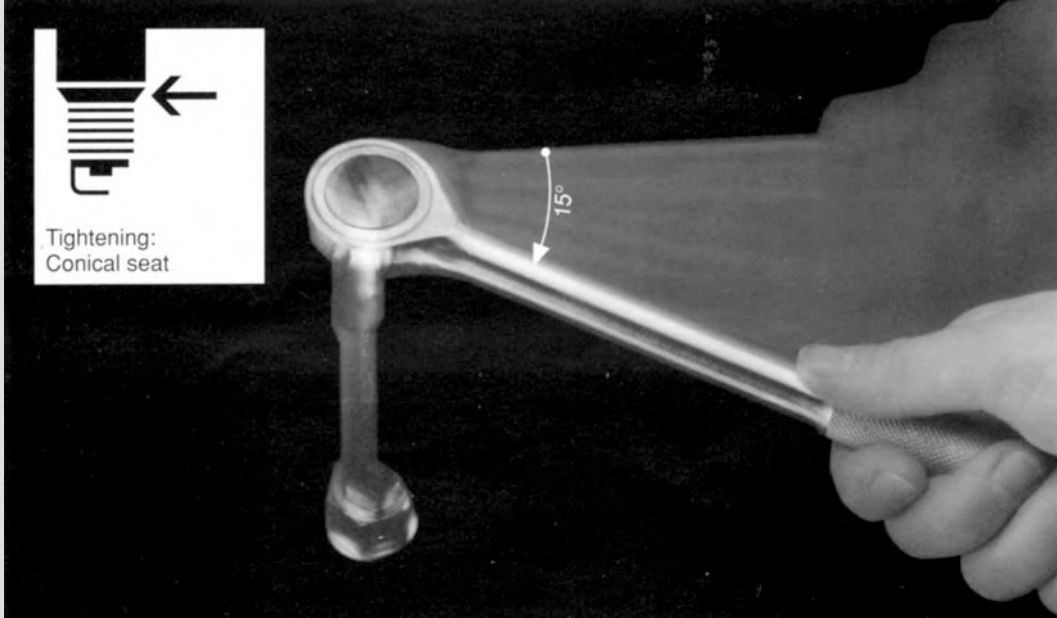
Spark Plug Tightening Torque

Tightening for a Flat or Conical Seal

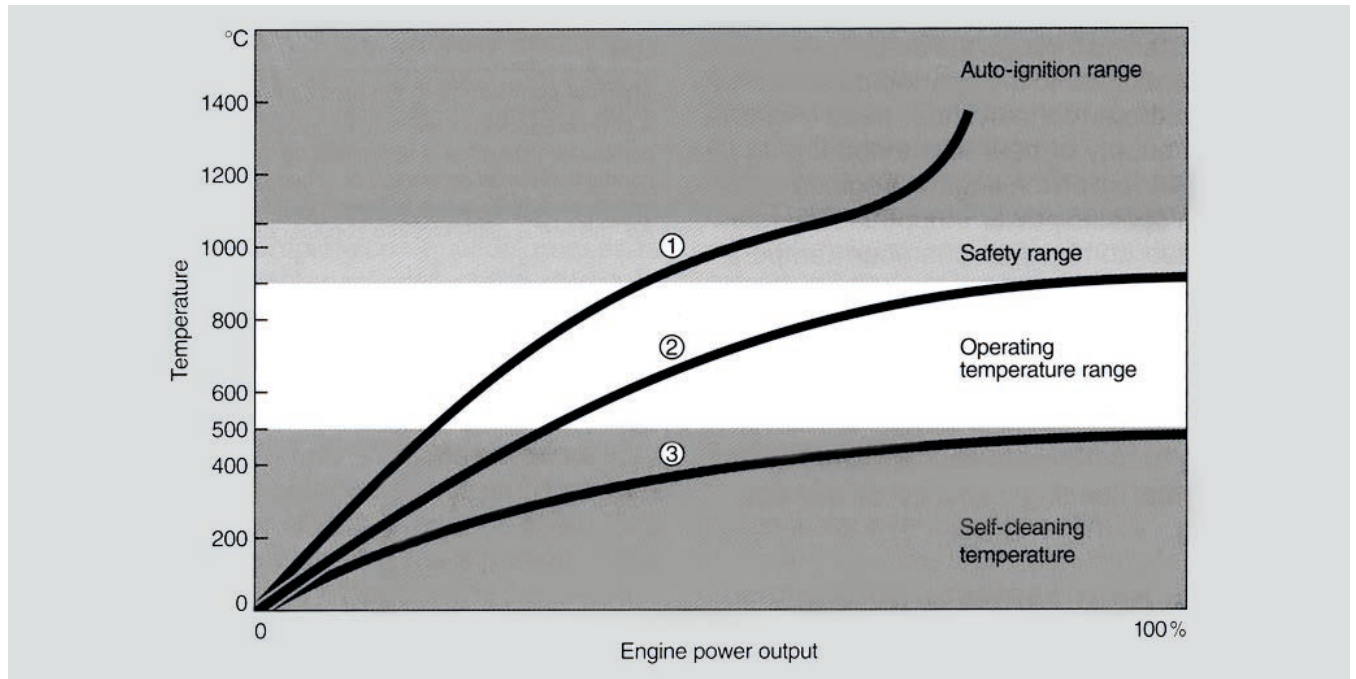
Temperature curves of spark plugs with different heat-range code numbers at full load in the same engine.

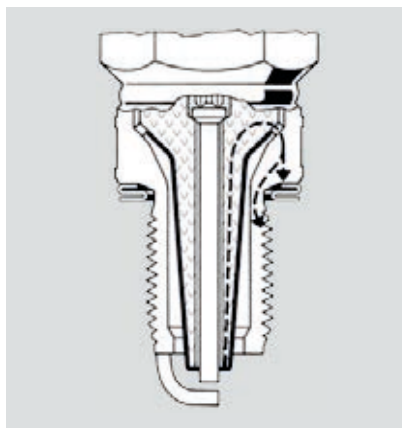
□ Spark plug with high heat-range code number (“hot plug”). Large insulator nose area absorbs much heat, low heat dissipation.

— Heat-absorbing surface
 - - - - Thermal conduction path

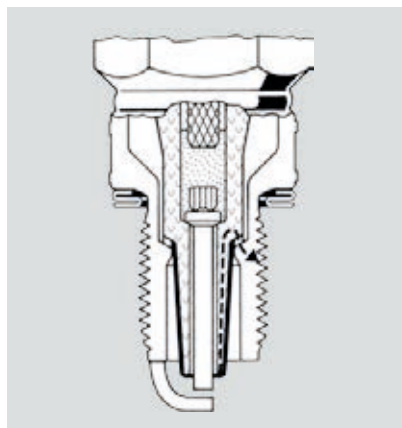
□ Spark plug with medium heat-range code number. Insulator nose area smaller than in “hot plug”. Lower heat absorption, better heat dissipation.

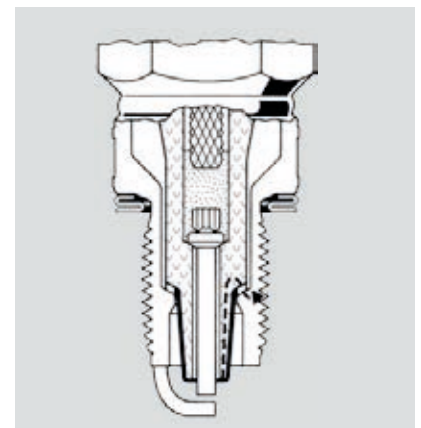
□ Spark plug with low heat-range code number (“cold plug”). Smaller insulator nose area absorbs little heat. Very good heat dissipation through short thermal conduction path.

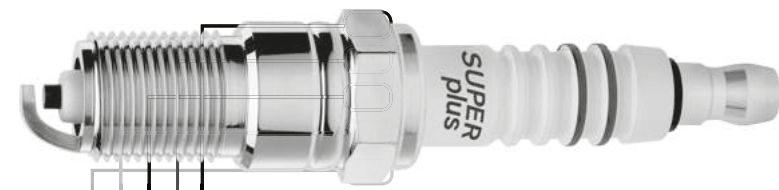
Center electrode with welded-on platinum wafer Diameter 0.8 or 1.1 mm possible	Center electrode with welded-on platinum wafer Diameter 0.6 or 0.8 mm possible	Ground electrode Mono nickel-yttrium	Ground electrode Binary nickel-yttrium	Ground electrode Mono nickel-yttrium with laser-alloyed platinum inlay	Ground electrode Binary nickel-yttrium with laser-alloyed platinum inlay
10	●	-	●	-	-	-
15	●	-	●	-	-	-
22	●	-	-	-	●	-
222	●	-	-	-	-	●
23	-	●	-	-	●	-
232	-	●	-	-	-	●
30	-	●	●	-	-	-
302	-	●	-	●	-	-
33	-	●	-	-	●	-
332	-	●	-	-	-	●
